PCB FREE

How Good Communication & Teamwork
turned a
“Supplemental Environmental Project”
into a
“Successful Environmental Project”

TXI Texas Cement & Expanded Shale & Clay

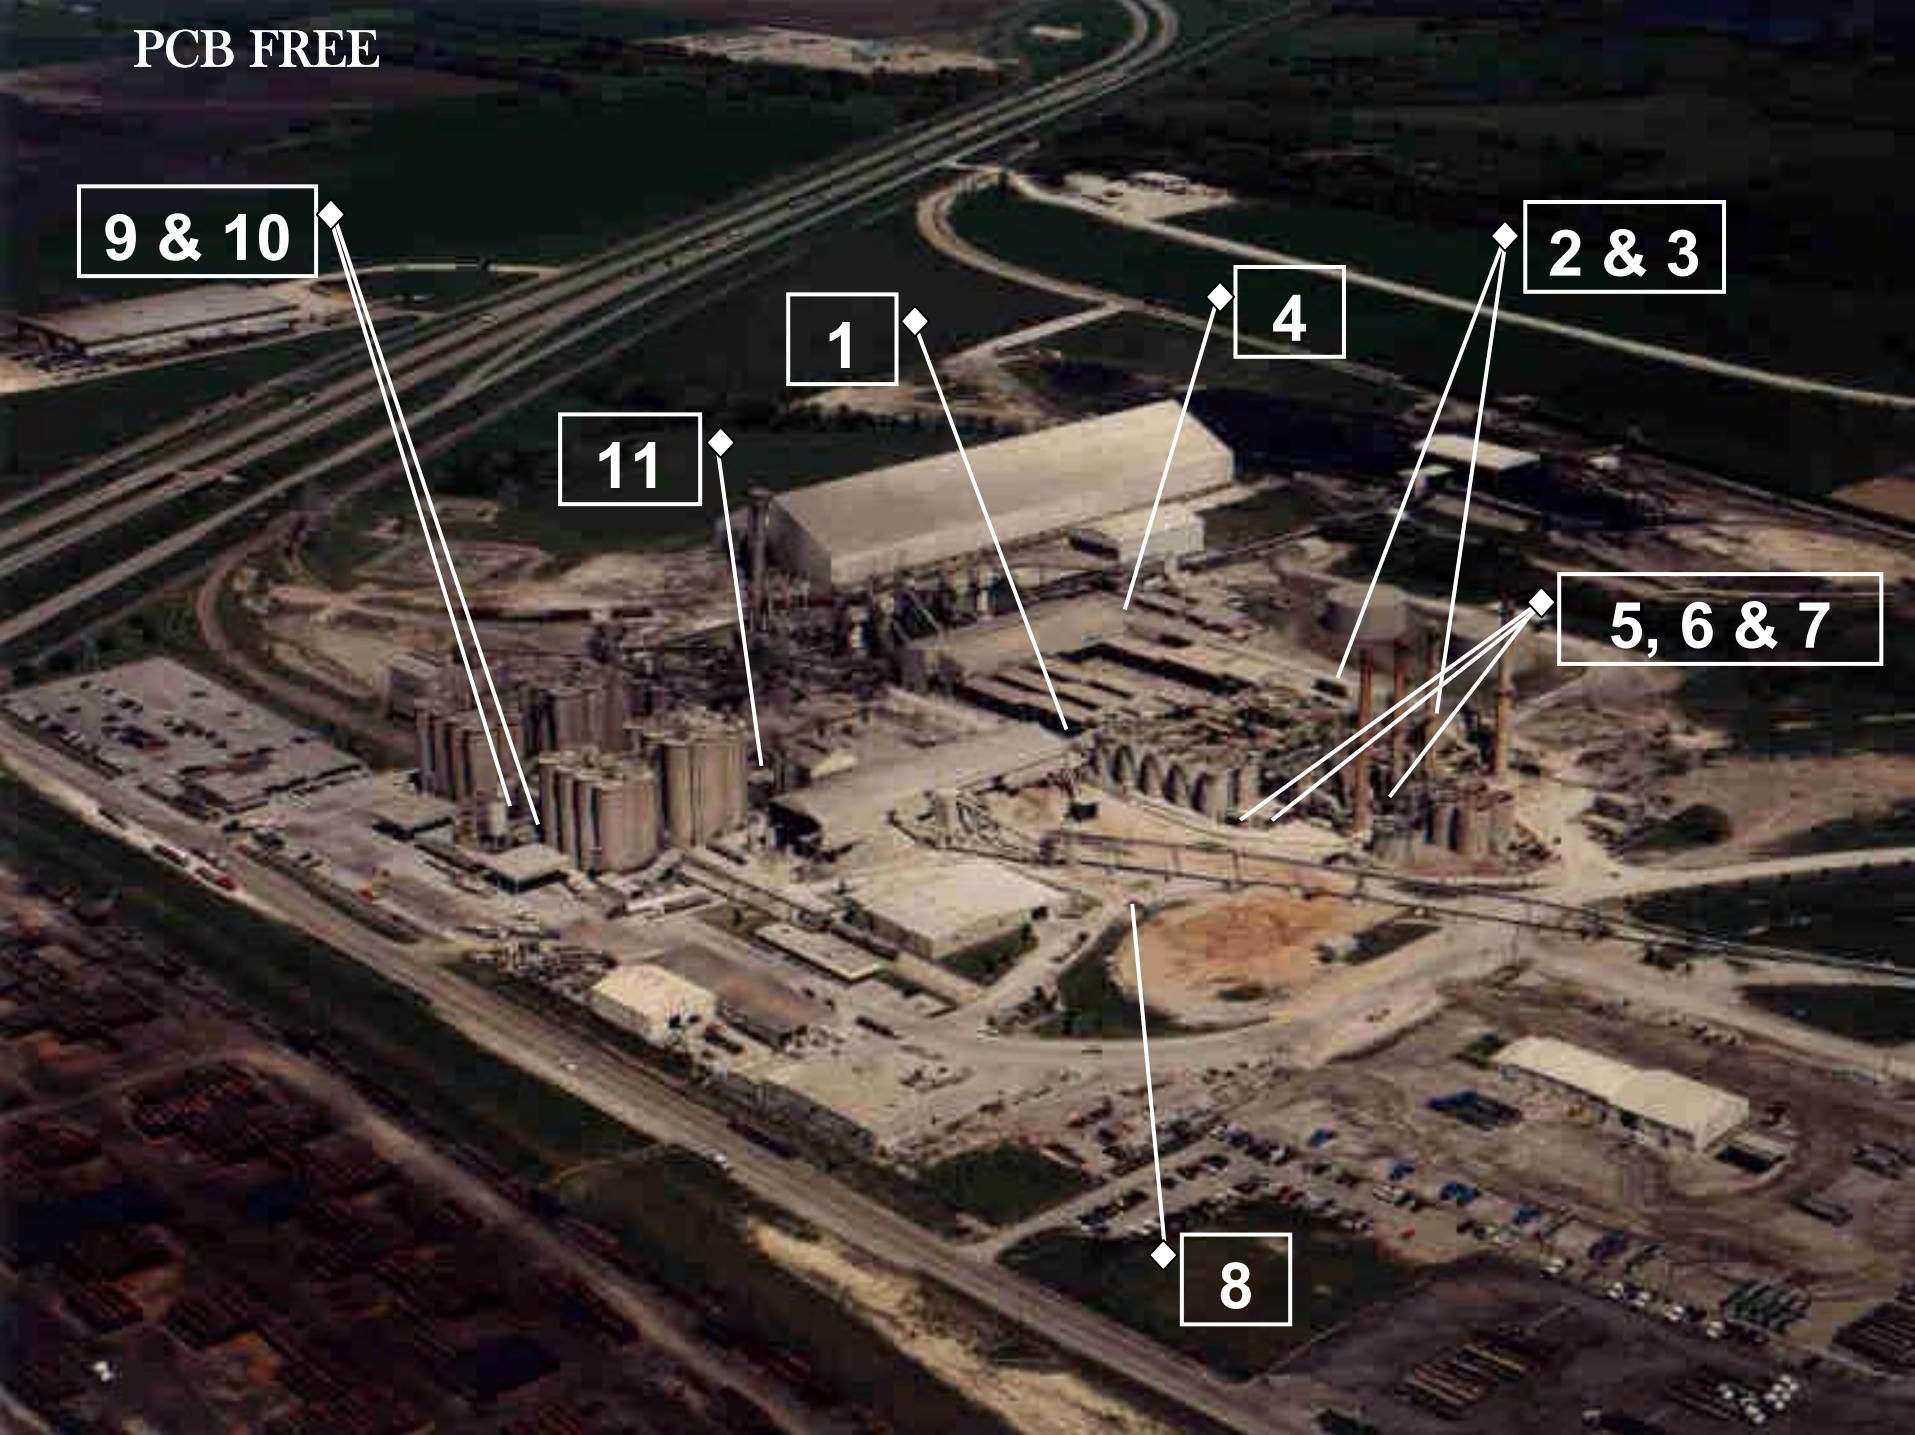
9 & 10

1

11

4

2 & 3

5, 6 & 7

8
